# Transportation facility assessment for bat use in Contra Costa County

## MONOGRAPH

Robert Stanley\*

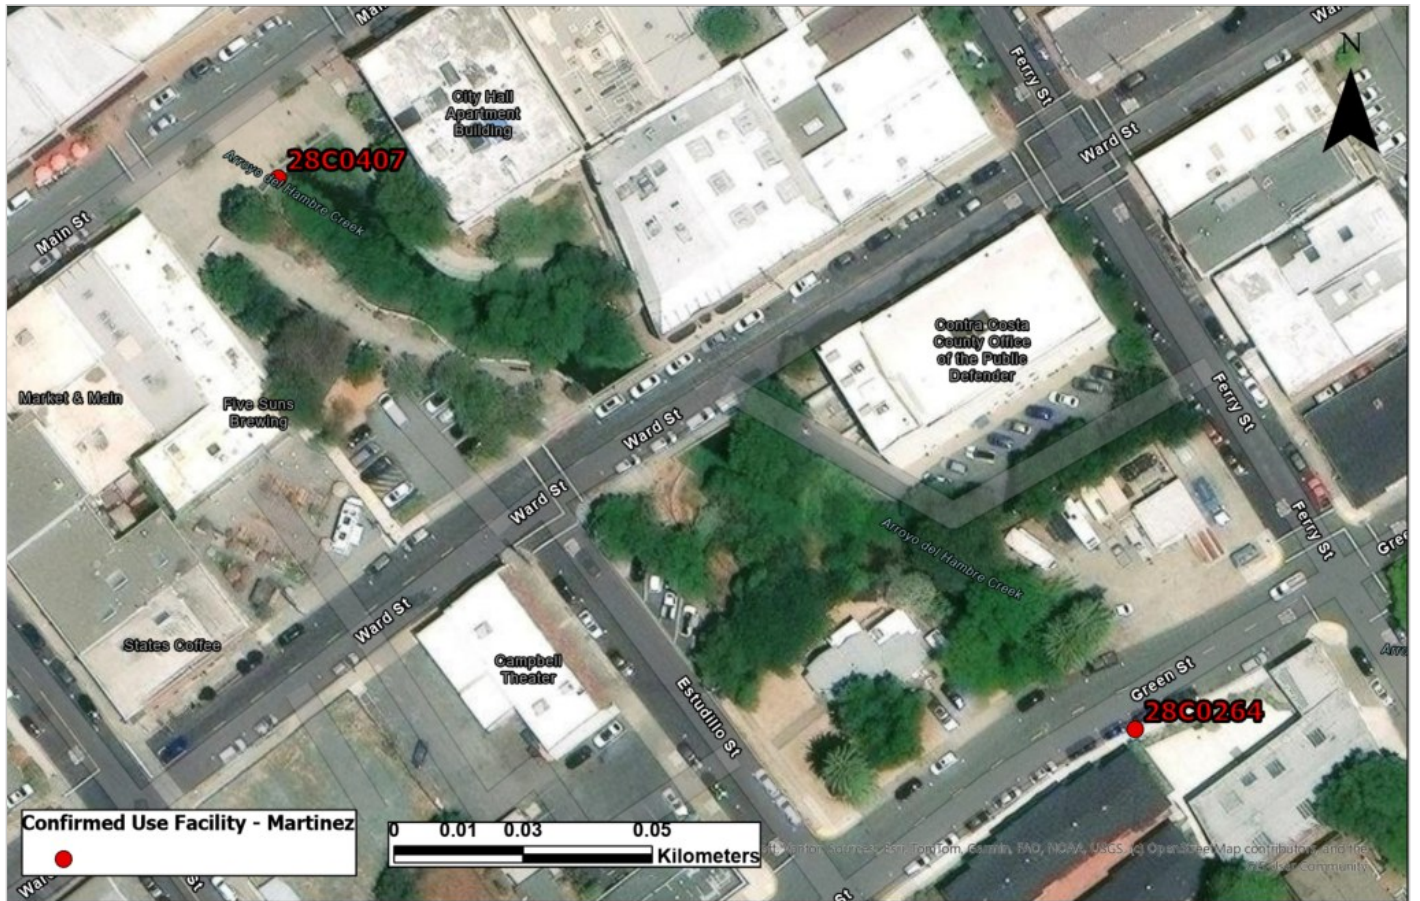
## Confirmed Use Facilities - Martinez

**Figure 6.** Two confirmed use facilities in Martinez, Contra Costa County, California, USA, are shown as red circles and labeled with their corresponding structure ID. This cluster is identified as Martinez based on its location.

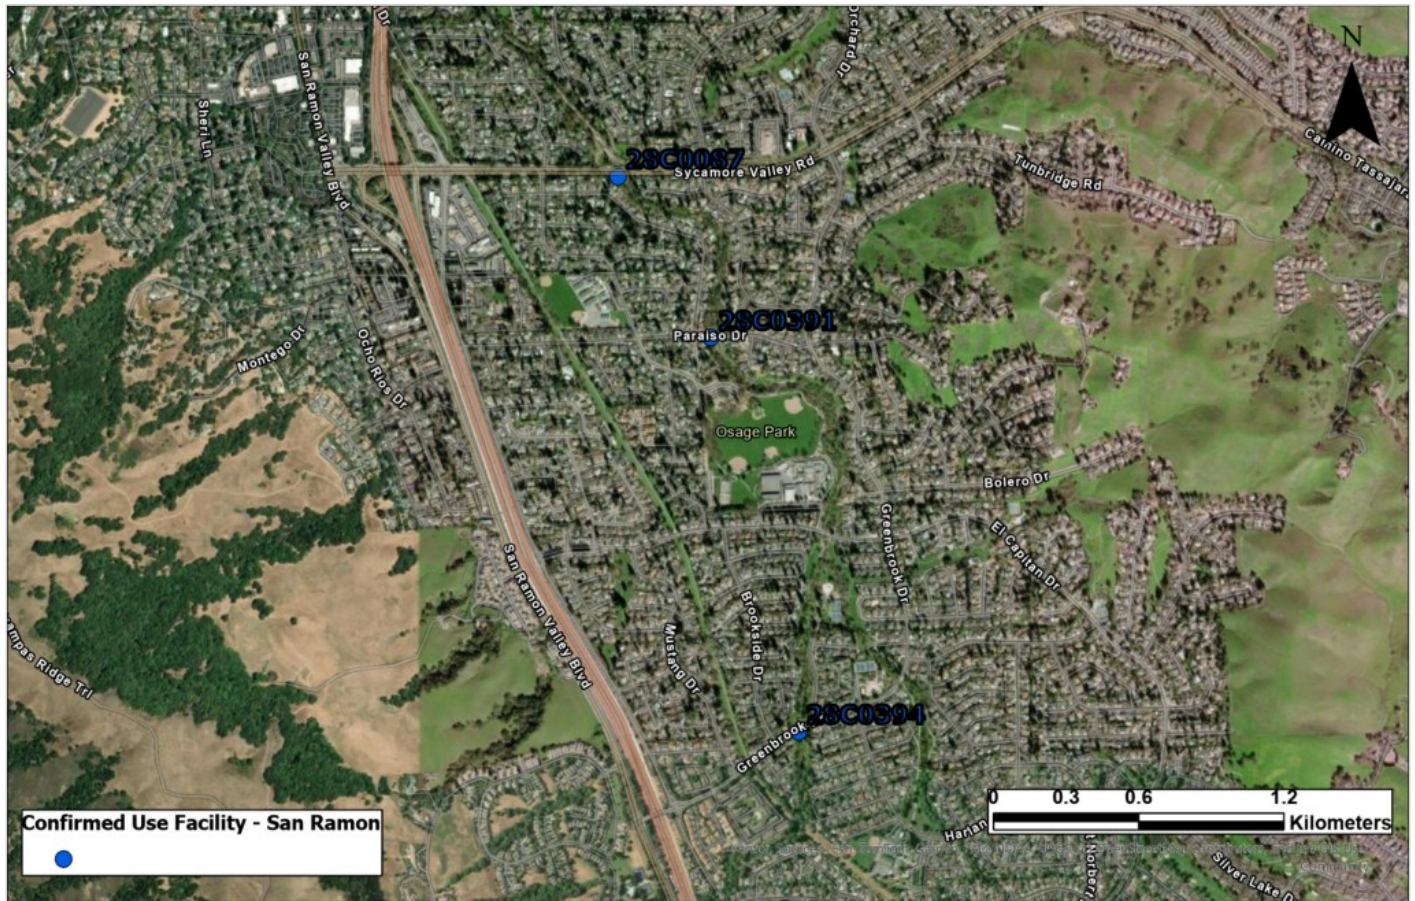
## Confirmed Use Facilities - San Ramon

**Figure 9.** Three confirmed use facilities in the vicinity of the City of San Ramon, Contra Costa County, California, USA, are shown as blue circles and labeled with their corresponding structure ID numbers. This cluster is identified as San Ramon based on its location.

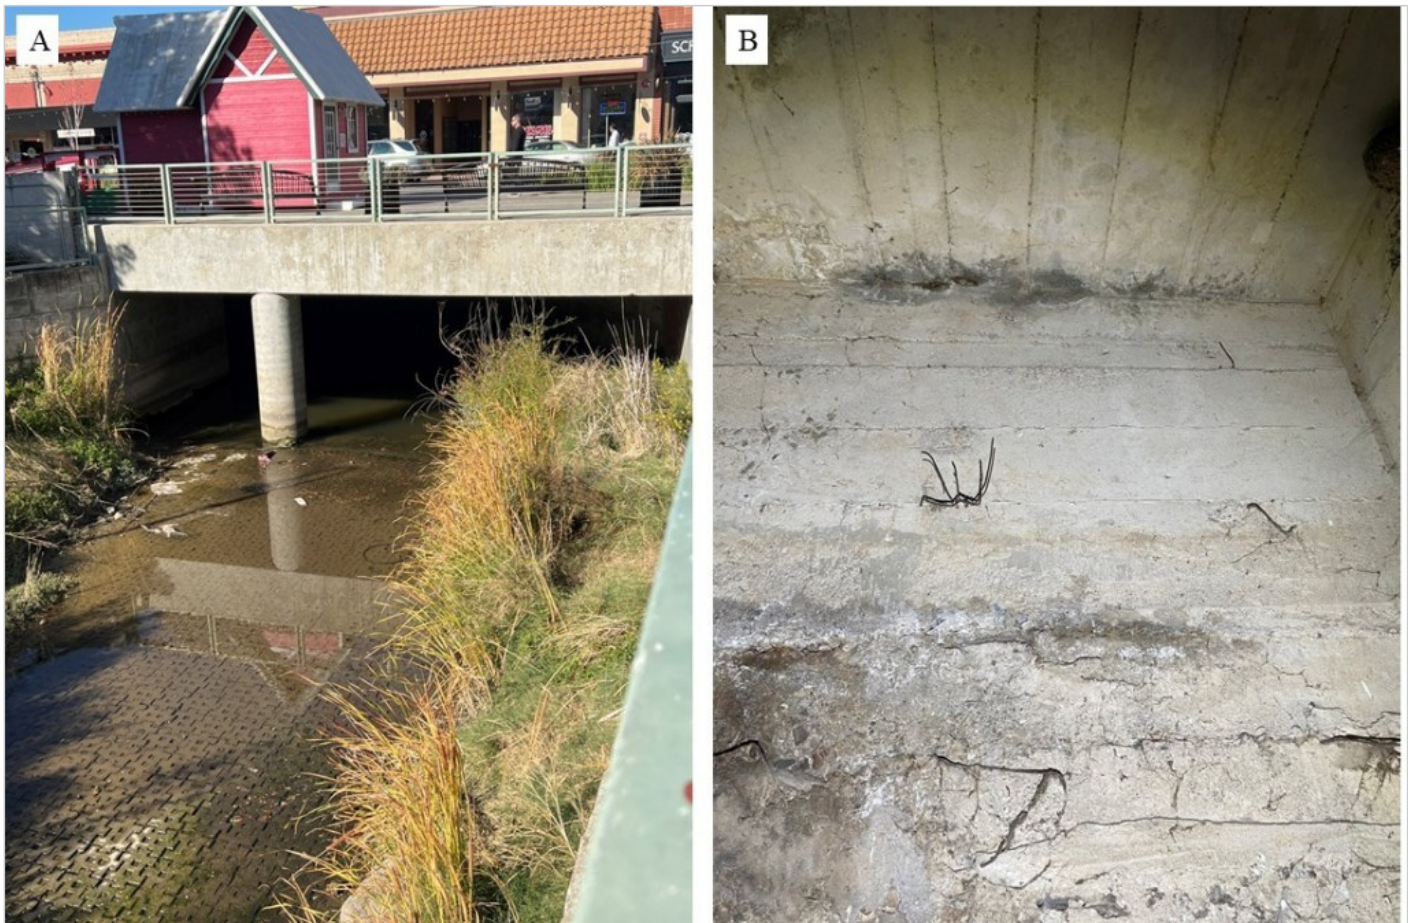
**Figure 14.** (A) Arroyo del Hombre Bridge – Structure ID 28 C0407. Superstructure of structure ID 28 C0407 facility in downtown Martinez, Contra Costa County, California, USA, along Arroyo del Hombre Creek. (B) Arroyo del Hombre Bridge – Structure ID 28 C0407. Substructure of structure ID 28 C0407 facility in downtown Martinez, Contra Costa County, California, USA, along Arroyo del Hombre Creek. Guano staining.

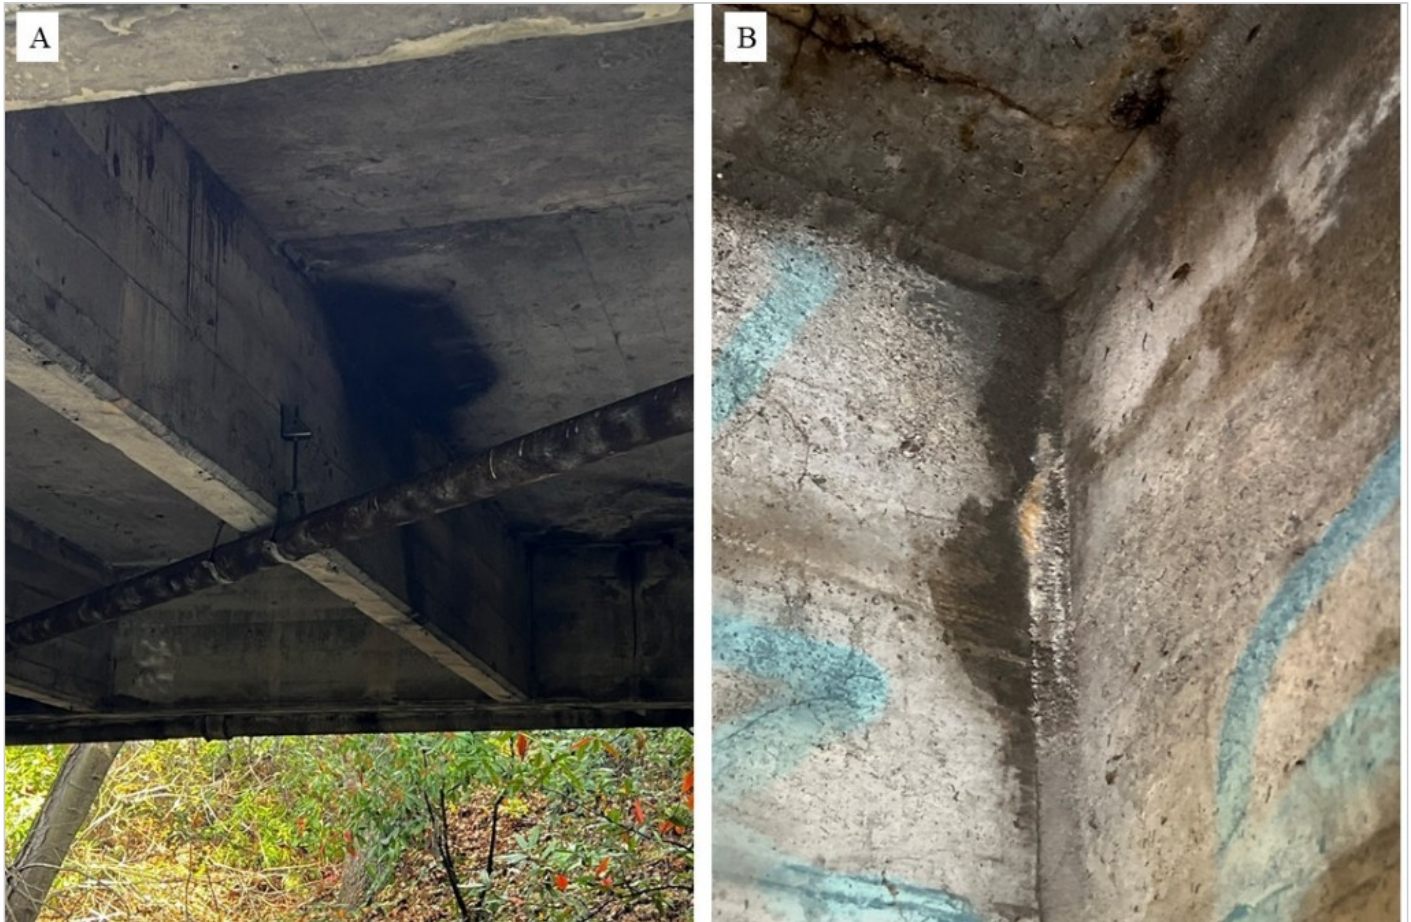
**Figure 16.** (A) Lafayette Creek Bridge Circa 1915 - No Structure ID. Substructure of a circa 1915 bridge facility near the City of Lafayette, Contra Costa County, California, USA, along El Nido Ranch Road in proximity to Lafayette Reservoir. (B) Lafayette Creek Bridge Circa 1915 - No Structure ID. Guano staining on substructure of a circa 1915 bridge facility near the City of Lafayette, Contra Costa County, California, USA, along El Nido Ranch Road in proximity to Lafayette Reservoir.

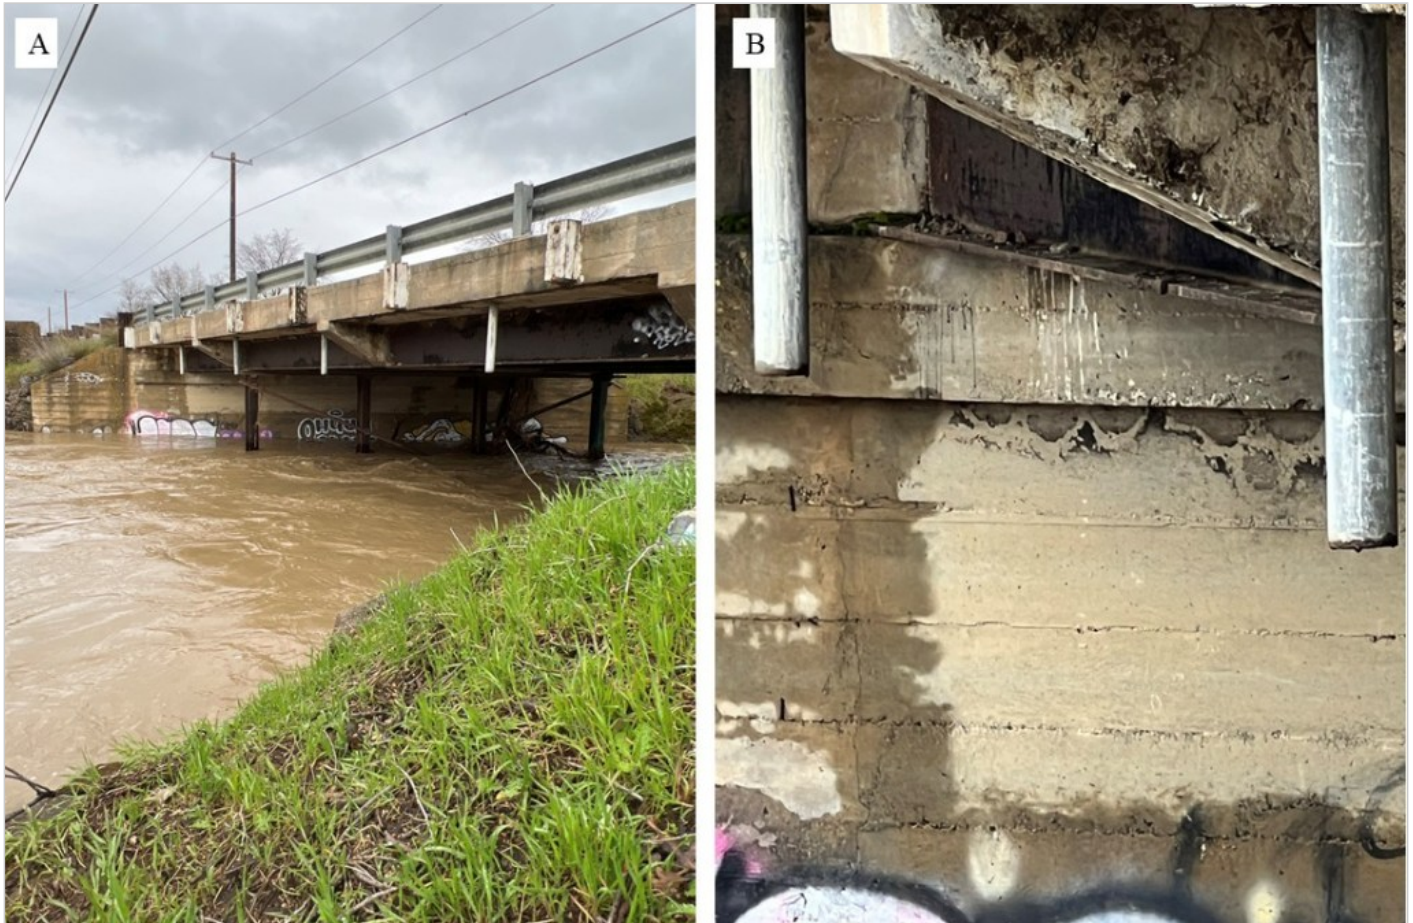
**Figure 18.** (A) Marsh Creek Structure ID – 28 C0145. Superstructure of structure ID 28 C0145 facilities near the City of Brentwood, Contra Costa County, California, USA, on Marsh Creek Road over Marsh Creek. This facility has been replaced since the field survey occurred. (B) Marsh Creek Structure ID – 28 C0145. Guano staining on the superstructure of structure ID 28 C0145 facility near the City of Brentwood, Contra Costa County, California, USA, on Marsh Creek Road over Marsh Creek.

Facility owners replaced structure ID 28 C0145 and 28 C0143 following completion of this assessment along Marsh Creek Road in the Diablo East cluster with modern prestressed girder (P-type) designs. The assessment classified the previous facilities as a confirmed use facility (T-beam) and a potential use facility (multi-beam girder), respectively. The assessment did not survey the replacement facilities (see [Discussion](#)).

Two facilities located within the Diablo East cluster, structure IDs 28 C0145 (confirmed use) and 28 C0143 (potential use), were replaced following completion of field surveys, and the assessment did not conduct follow-up field surveys. Evaluation of the two replacement facilities with previous confirmed and potential use would further inform whether roost function persists following replacement with modern design specifications and whether changes in structural configuration influence continued bat occupancy.

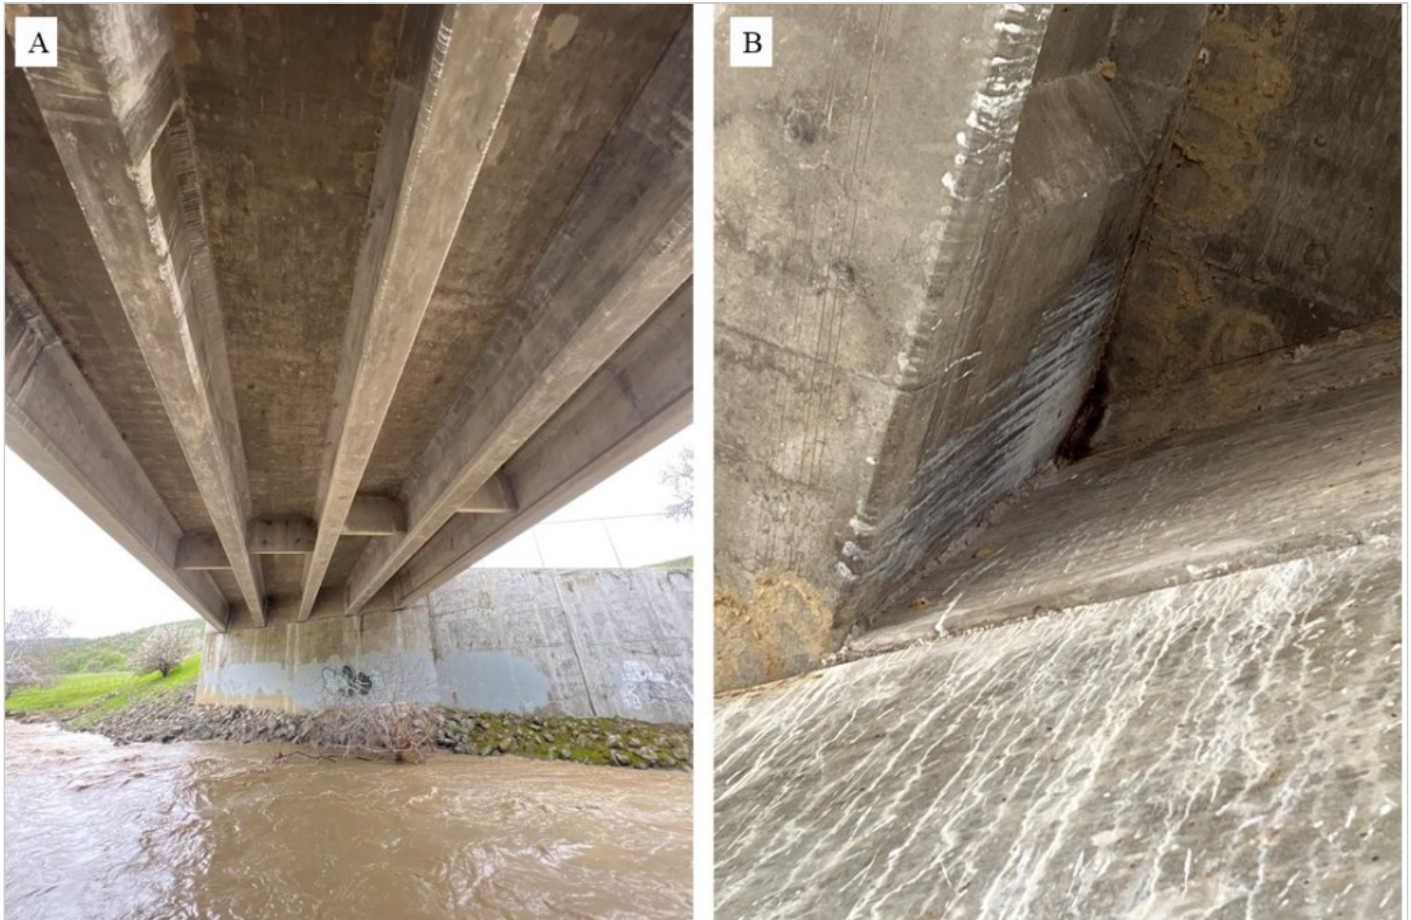
**Figure 19.** (A) Marsh Creek Bridge - Structure ID 28 C0124. Substructure of structure ID 28 C0124 facility near Marsh Creek Springs, Contra Costa County, California, USA, on Marsh Creek Road over Marsh Creek. (B) Marsh Creek Bridge - Structure ID 28 C0124. Guano staining on the substructure of structure ID 28 C0124 facility near Marsh Creek Springs, Contra Costa County, California, USA, on Marsh Creek Road over Marsh Creek.

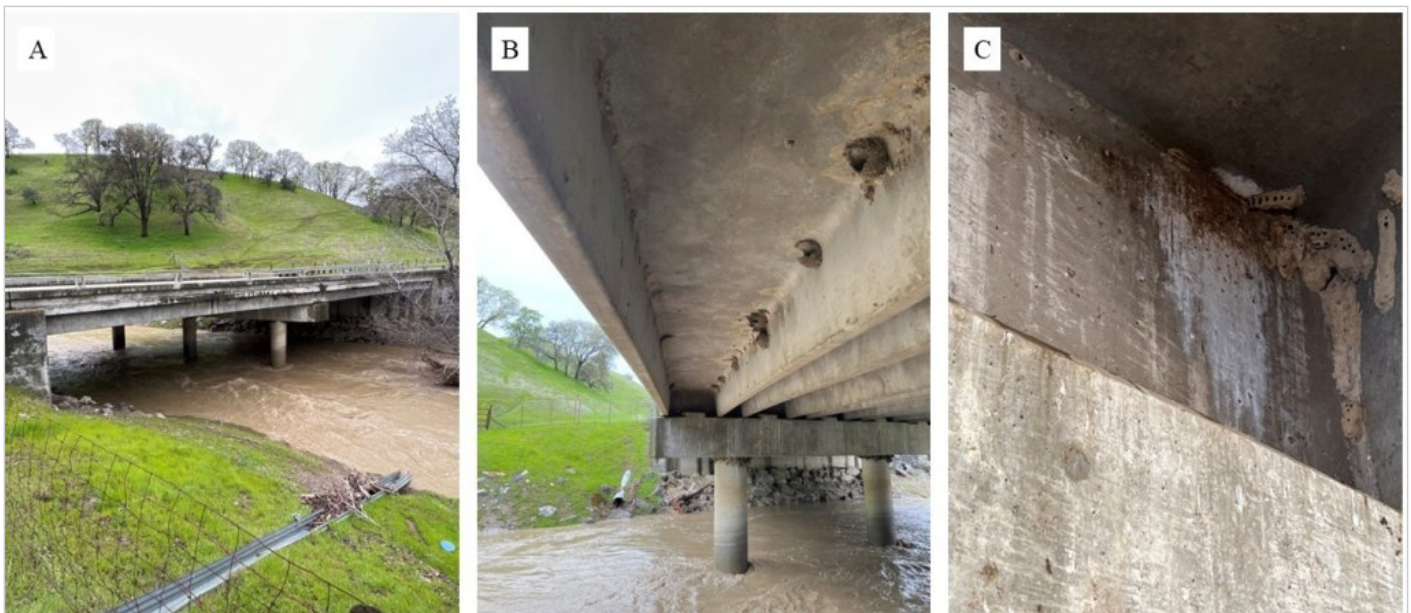
**Figure 20.** (A) Marsh Creek Bridge – Structure ID 28 C0144. Surrounding site and superstructure of structure ID 28 C0144 facility near Marsh Creek Springs, Contra Costa County, California, USA, on Marsh Creek Road over Marsh Creek. (B) Marsh Creek Bridge – Structure ID 28 C0144. Substructure of structure ID 28 C0144 facility near Marsh Creek Springs, Contra Costa County, California, USA, on Marsh Creek Road over Marsh Creek, showing swallow nests. (C) Marsh Creek Bridge – Structure ID 28 C0144. Substructure of structure ID 28 C0144 facility near Marsh Creek Springs, Contra Costa County, California, USA, on Marsh Creek Road over Marsh Creek, showing wasp nests and guano staining.

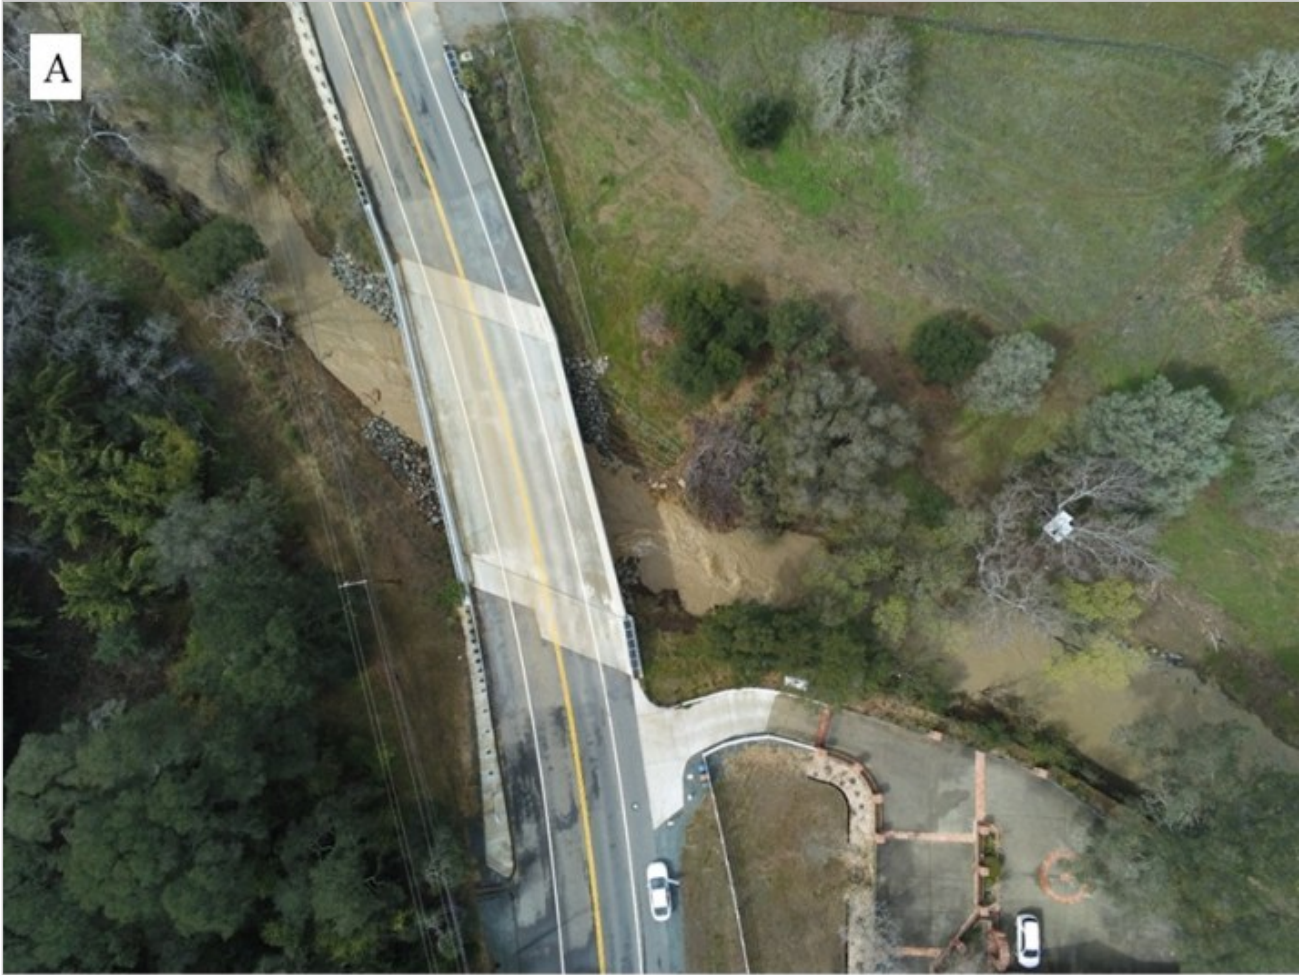
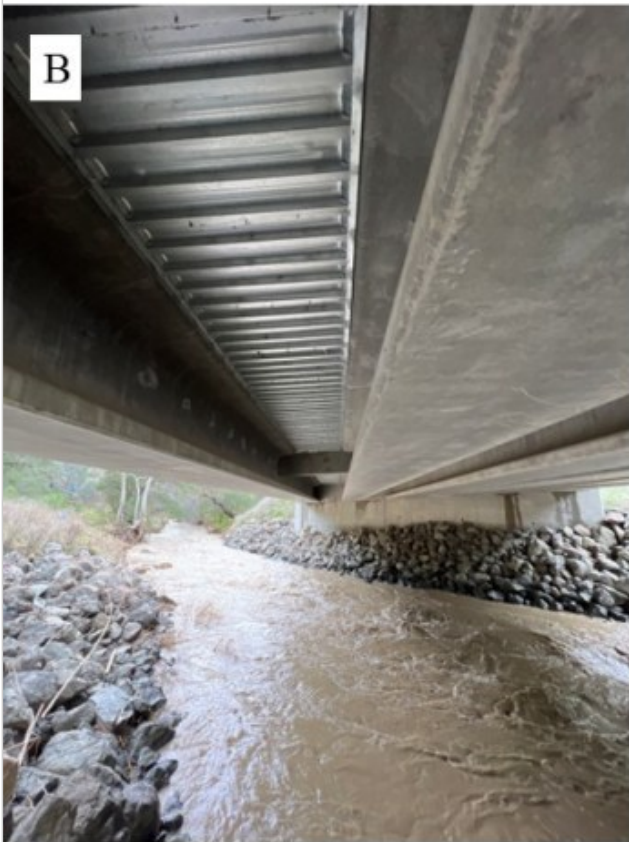
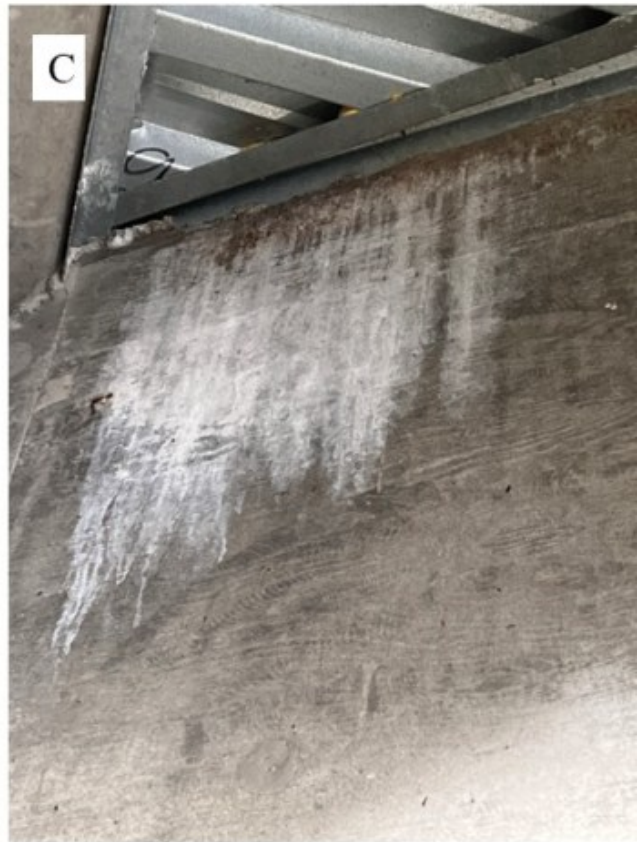
**Figure 21.** (A) Marsh Creek Bridge – Structure ID 28 C0273. UAV aerial view of the site of structure ID 28 C0273 facility near Marsh Creek Springs, Contra Costa County, California, USA, on Marsh Creek Road over Marsh Creek. (B) Marsh Creek Bridge – Structure ID 28 C0273. Substructure design of structure ID 28 C0273 facility near Marsh Creek Springs, Contra Costa County, California, USA, on Marsh Creek Road over Marsh Creek. (C) Marsh Creek Bridge – Structure ID 28 C0273. Substructure of structure ID 28 C0273 facility near Marsh Creek Springs, Contra Costa County, California, USA, on Marsh Creek Road over Marsh Creek, showing guano staining.

Despite differences in construction era, confirmed use facilities in the Diablo East cluster, both constructed in 2018, structure ID 28 C0273 (replacement facility) and 28 C0411R (new facility), incorporated modern prestressed girder designs yet retained deep underdeck recesses, beam spacing, and void configurations comparable to older multi-span facilities that supported bat use. This suggests that roost suitability was more closely associated with structural form and void geometry than with facility age alone.

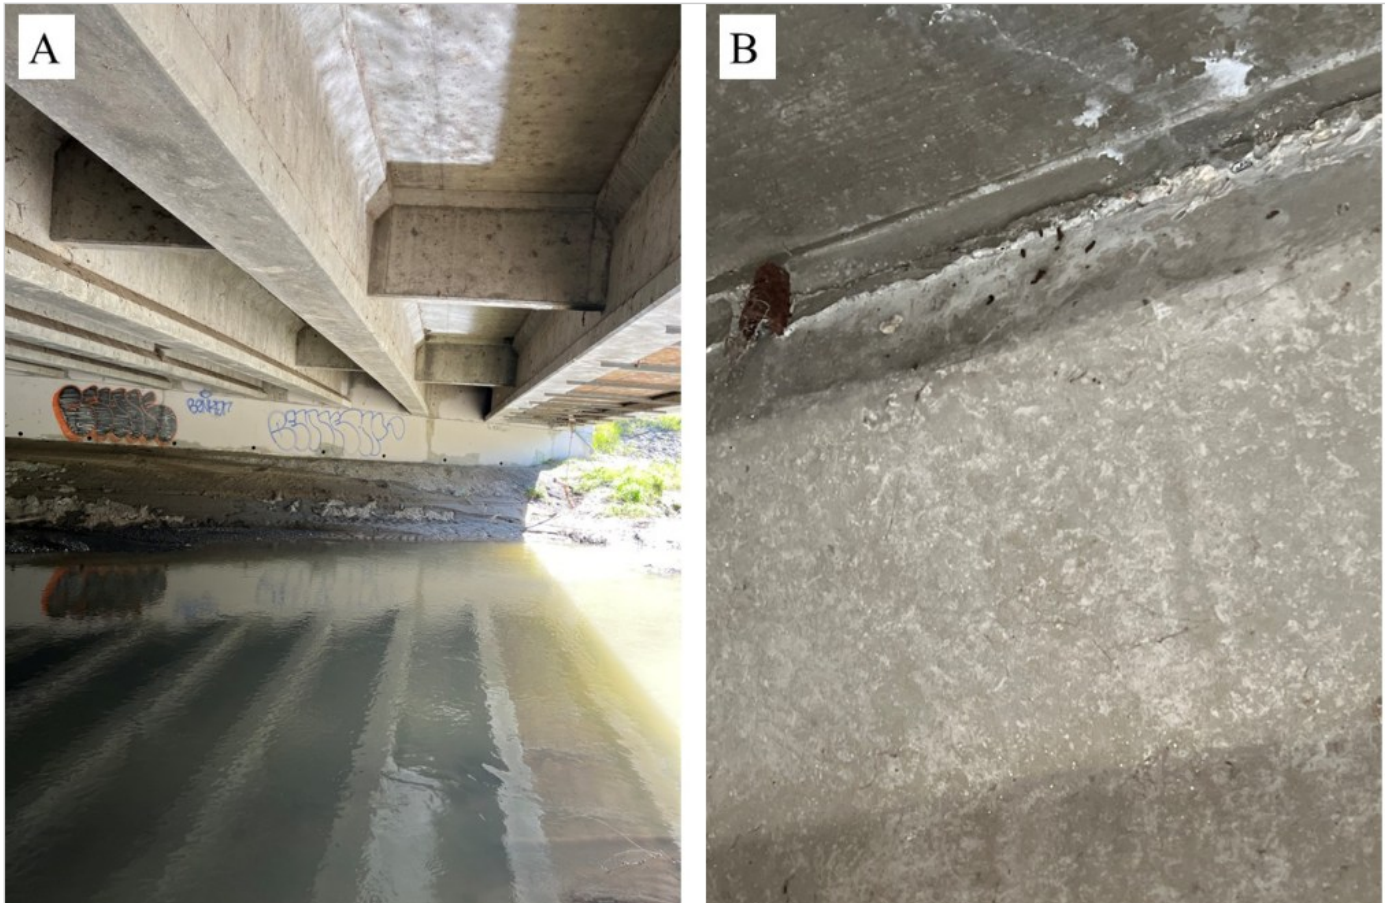
**Figure 22.** (A) San Ramon Creek Bridge – Structure ID 28 C0087. Substructure of structure ID 28 C0087 facility over San Ramon Creek in Contra Costa County, California, USA. (B) San Ramon Creek Bridge – Structure ID 28 C0087. Substructure of structure ID 28 C0087 facility over San Ramon Creek in Contra Costa County, California, USA, showing guano staining.

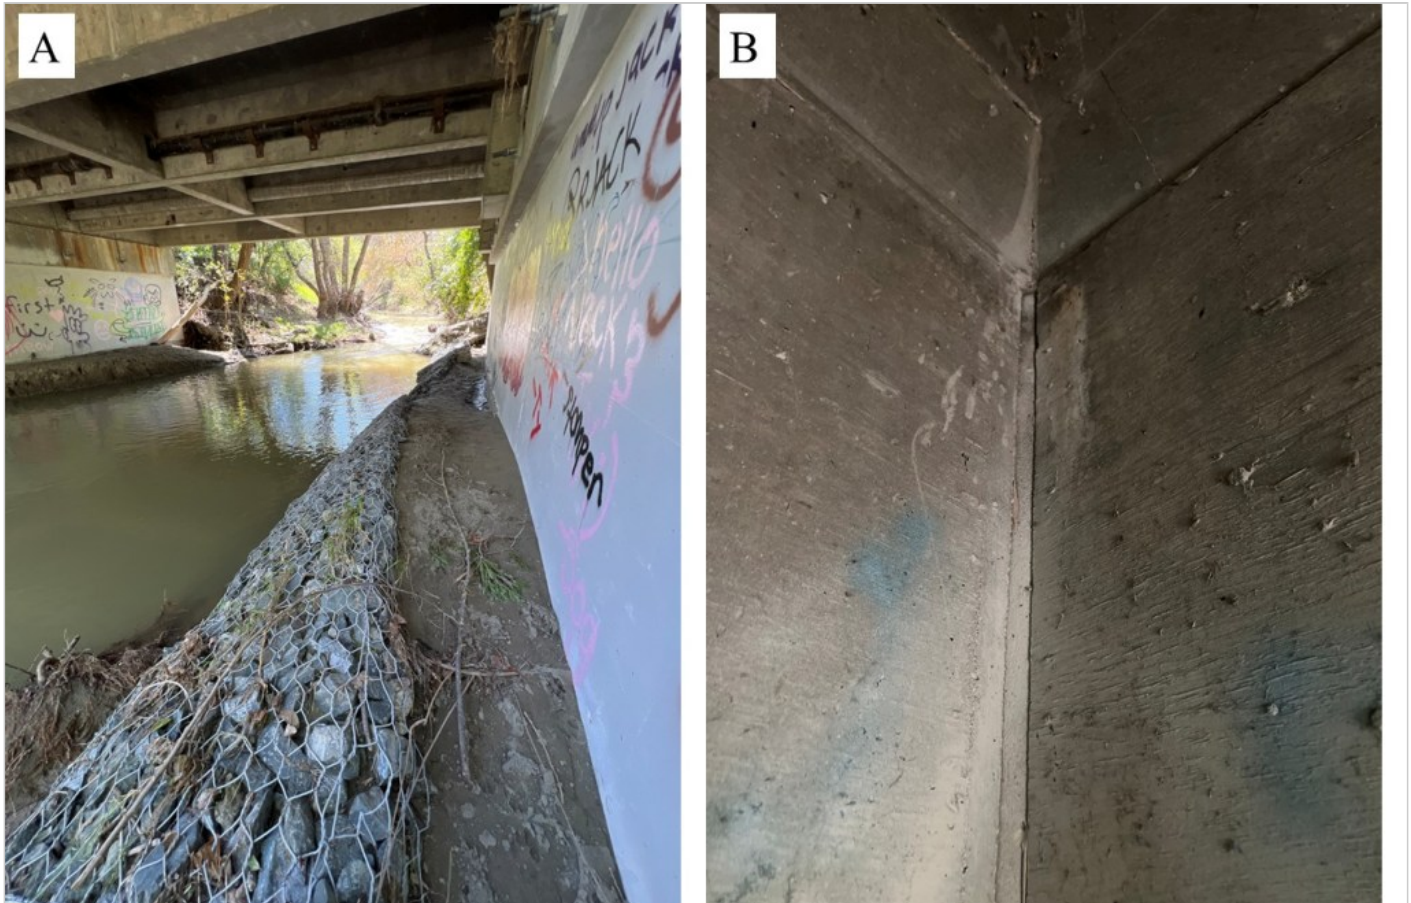
**Figure 23.** (A) San Ramon Creek Bridge – Structure ID 28 C0391. Substructure of structure ID 28 C0391 facility over San Ramon Creek in Contra Costa County, California, USA. (B) San Ramon Creek Bridge – Structure ID 28 C0391. Guano staining in a corner joint of structure ID 28 C0391 facility over San Ramon Creek in Contra Costa County, California, USA.

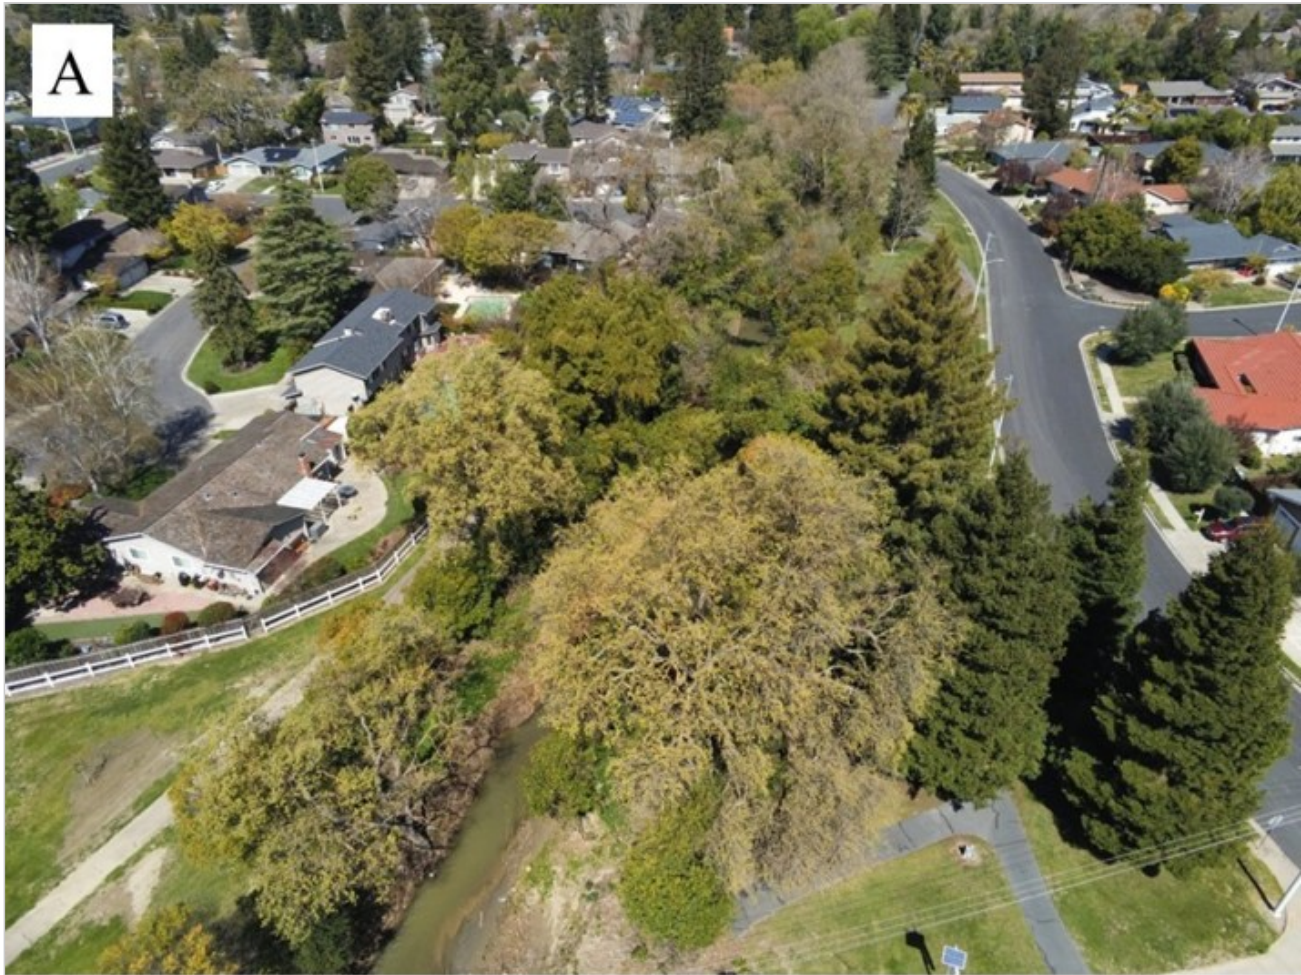
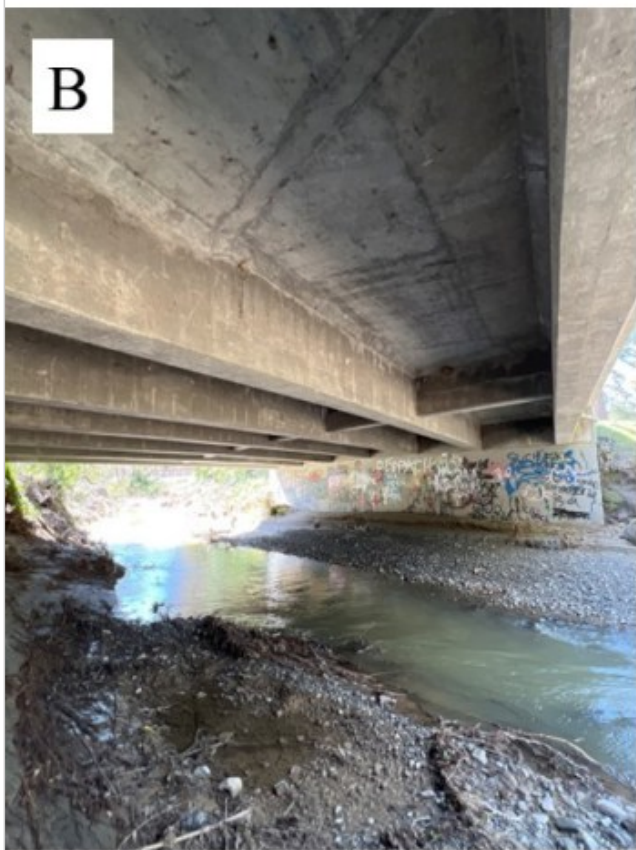
**Figure 24.** (A) San Ramon Creek Bridge – Structure ID 28 C0394. UAV aerial view of the site of structure ID 28 C0394 facility over San Ramon Creek in Contra Costa County, California, USA. (B) San Ramon Creek Bridge – Structure ID 28 C0394. Substructure of structure ID 28 C0394 facility over San Ramon Creek in Contra Costa County, California, USA. (C) San Ramon Creek Bridge – Structure ID 28 C0394. Substructure of structure ID 28 C0394 facility over San Ramon Creek in Contra Costa County, California, USA, showing guano staining.
