# Observations of wildlife entrapment in cattle guards, with special consideration for special-status herpetofauna

## RESEARCH NOTE

Published 21 May 2025 • [doi.org/10.51492/cfwj.111.11](https://doi.org/10.51492/cfwj.111.11)

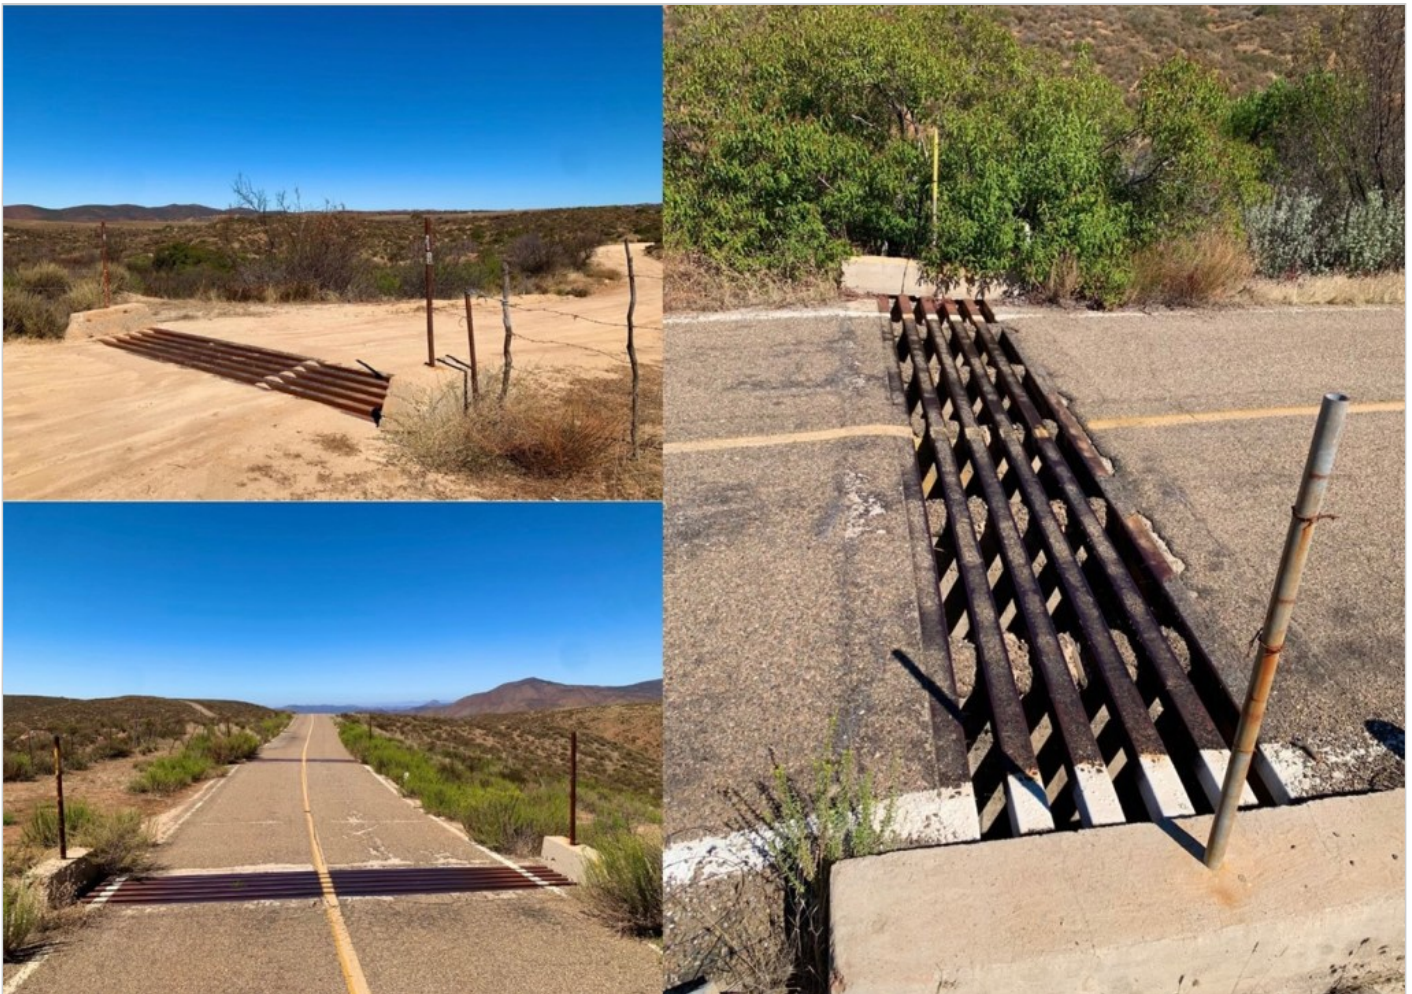
**Figure 2.** An example of cattle guards in Baja California. A) cattle guard at the access road to Rancho El Coyote; B and C) cattle guards on the highway that leads east to the Sierra San Pedro Mártir, Baja California, México.

Typically, cattle guards were made up of 6–14 pipes (or similar) that were arranged perpendicular to the direction of roadway traffic and spaced roughly 10 cm apart ([Fig. 2](#)). Below the pipes was a pit that was excavated to a depth ranging from 60 to 100 cm in California, or 45 to 150 cm in Baja California. These depressions were lined by a concrete box which held the cross pipes in place but also created a chamber that functioned as a large pitfall trap.

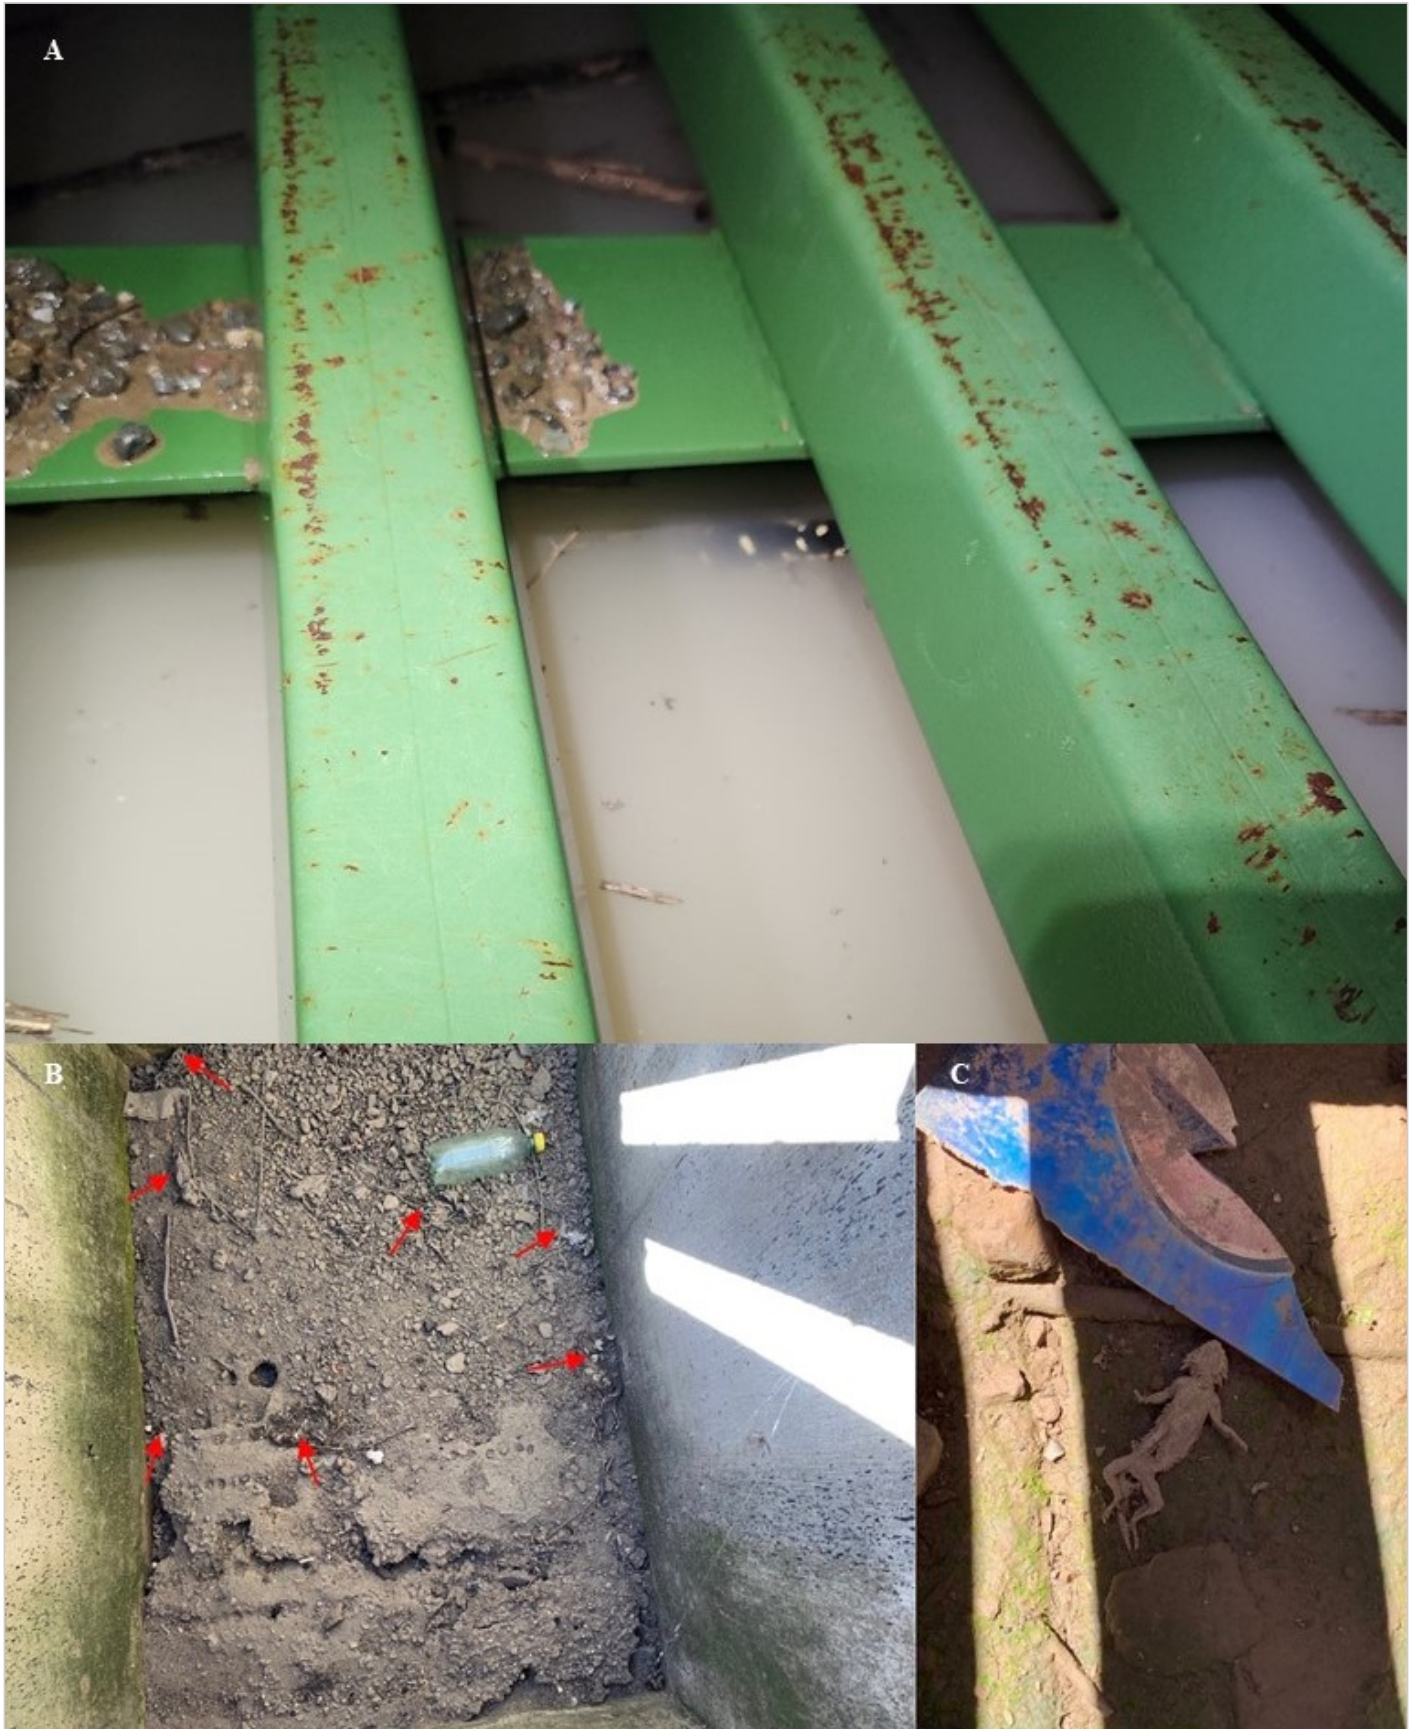
**Figure 3.** Entrapped wildlife encountered during cattle guard samples. A) a California tiger salamander trapped in a flooded cattle guard, Contra Costa County, CA, December 2022, photo by

Zach Fry; B) several dead *Dulzura* kangaroo rats (red arrows), photos by Jorge H. Valdez; C) a dead coast horned lizard (*Phrynosoma blainvillii*), San Pedro Mártir Road, Baja California, México, September 2023, photo by Jorge H. Valdez.

On one occasion, a federally threatened species of amphibian, a California tiger salamander (*Ambystoma californiense*), was trapped in a California cattle guard that was flooded with rainwater ([Fig. 3a](#)). On another occasion, also in California, we found 6 larvae and approximately 40 dead post-metamorphic western toads that were likely hatched from eggs that were laid in the cattle guard when it was inundated in winter. Based on our observations, flooded cattle guards may be an ecological trap for some amphibians by drawing them to an artificial pool habitat that has different drying rates than wetlands in the surrounding landscape.

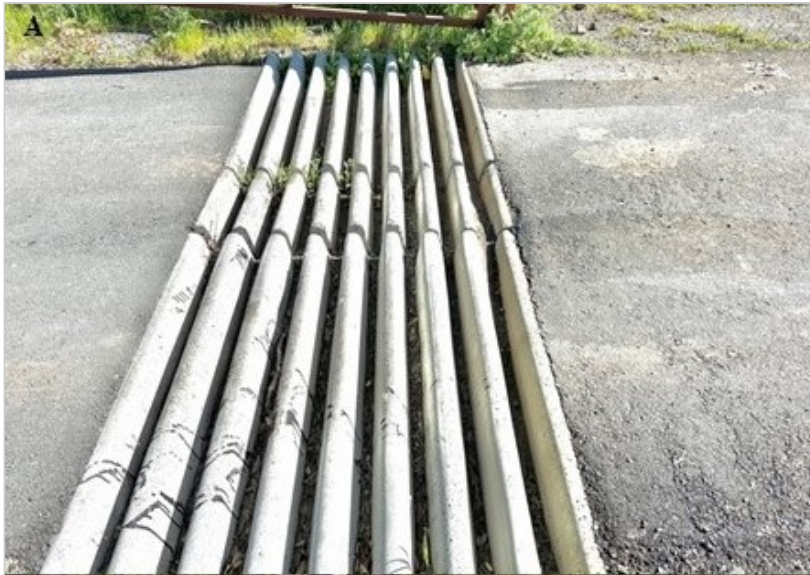
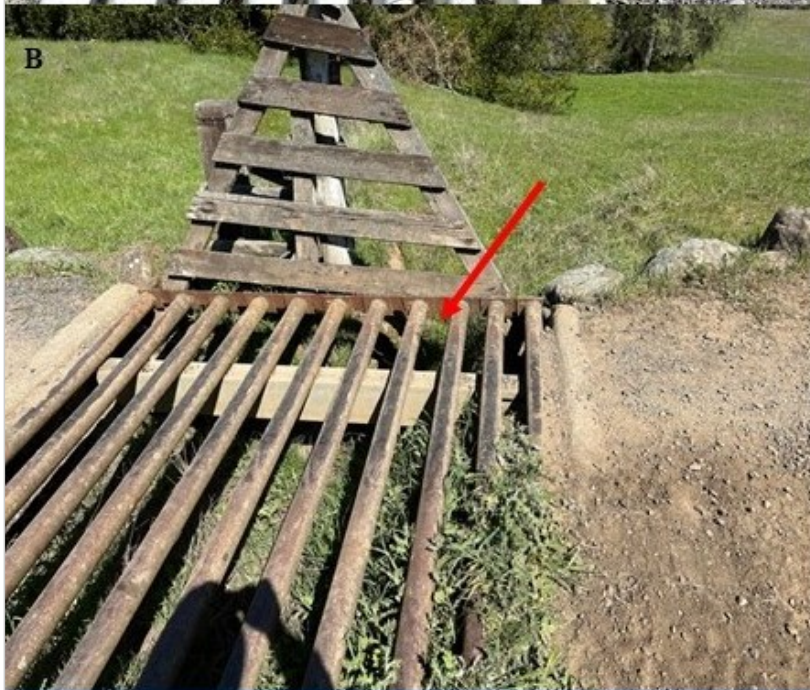
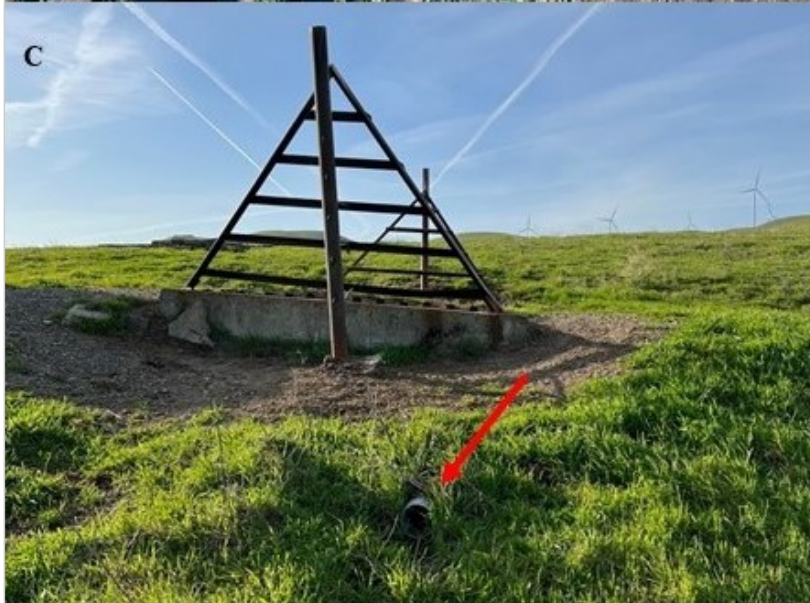
**Figure 4.** Several features of wildlife-friendly cattle guards in California that allow wildlife to self-release. (A) no lower chamber, Mitsui Ranch, Petaluma, California; (B) open sides (red arrow), Mitsui Ranch; (C) a pipe in the side (red arrow), Tres Vaqueros mitigation site, Brentwood, California. All photos by Jeff A. Alvarez, July 2023.

Although cattle guards can be designed to be functionally wildlife friendly, we have only observed this in Sonoma County, CA. One such design uses undulating concrete forms that mimic the horizontal bars in form and function but allow wildlife to walk out of the open edges ([Fig. 4a](#)). Other designs simply have open sides that allow water and debris to be flushed out, and wildlife to self-release ([Fig. 4b](#)). Another design includes a pipe installed on the sides that allows water and smaller wildlife species to leave the pit-portion of the cattle guard ([Fig. 4c](#)). We suggest that existing cattle guards be retrofitted to make them more wildlife-friendly. Retrofitting cattle guards in areas supporting threatened and endangered wildlife that may be vulnerable to entrapment can likely reduce mortality of protected species. We trialed a method of placing ramps (metal and wood) in some cattle guards to provide an escape mechanism for wildlife, but did not explicitly test their effectiveness. At the Baja California site, all ramps were immediately removed by people in the area, making this approach unlikely to work in some cases. We suggest that existing cattle guard pits could be retrofitted to minimize entrapment by filling them with gravel to the level of the horizontal crossbars/pipes. Alternatively, a small (15 cm long x 10 cm wide) ramp could be placed in each gap at the ends of and between crossbars/pipes to facilitate wildlife self-release.
